BRETT'S WATERWAY CAFÉ SUBSTRUCTURE CONDITION ASSESSMENT

For the
CITY OF FERNANDINA BEACH, FLORIDA

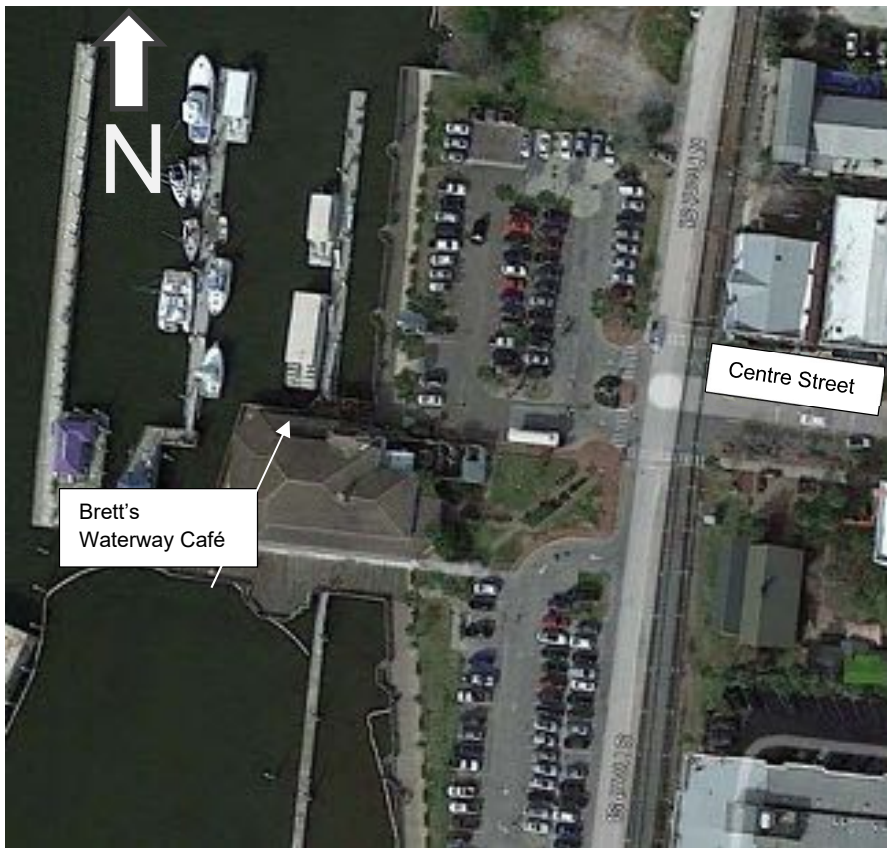
Aerial Image Courtesy of Google Earth Pro

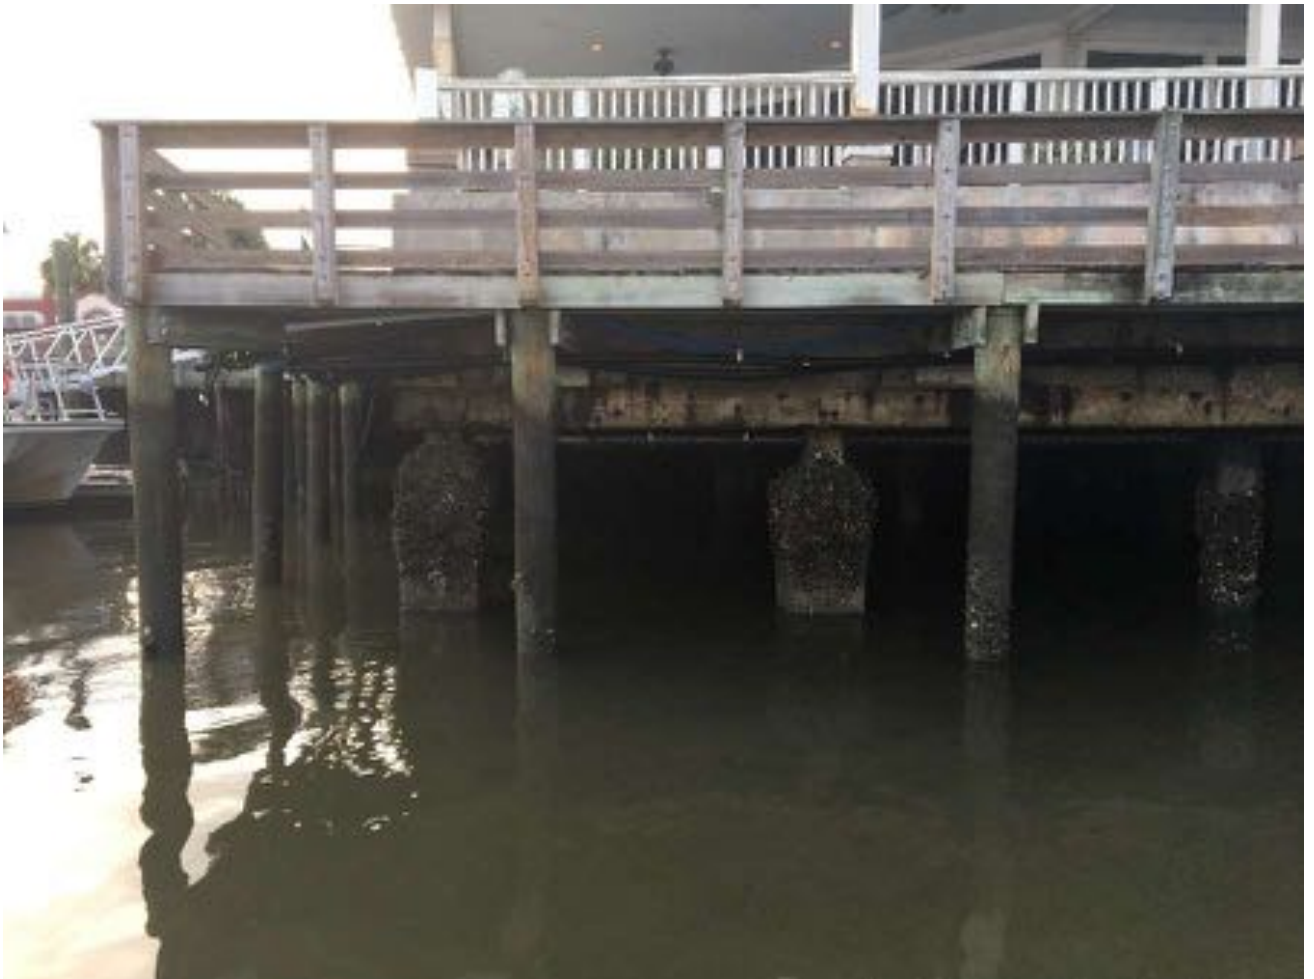
1.01~West Elevation at the Northwest corner of the building

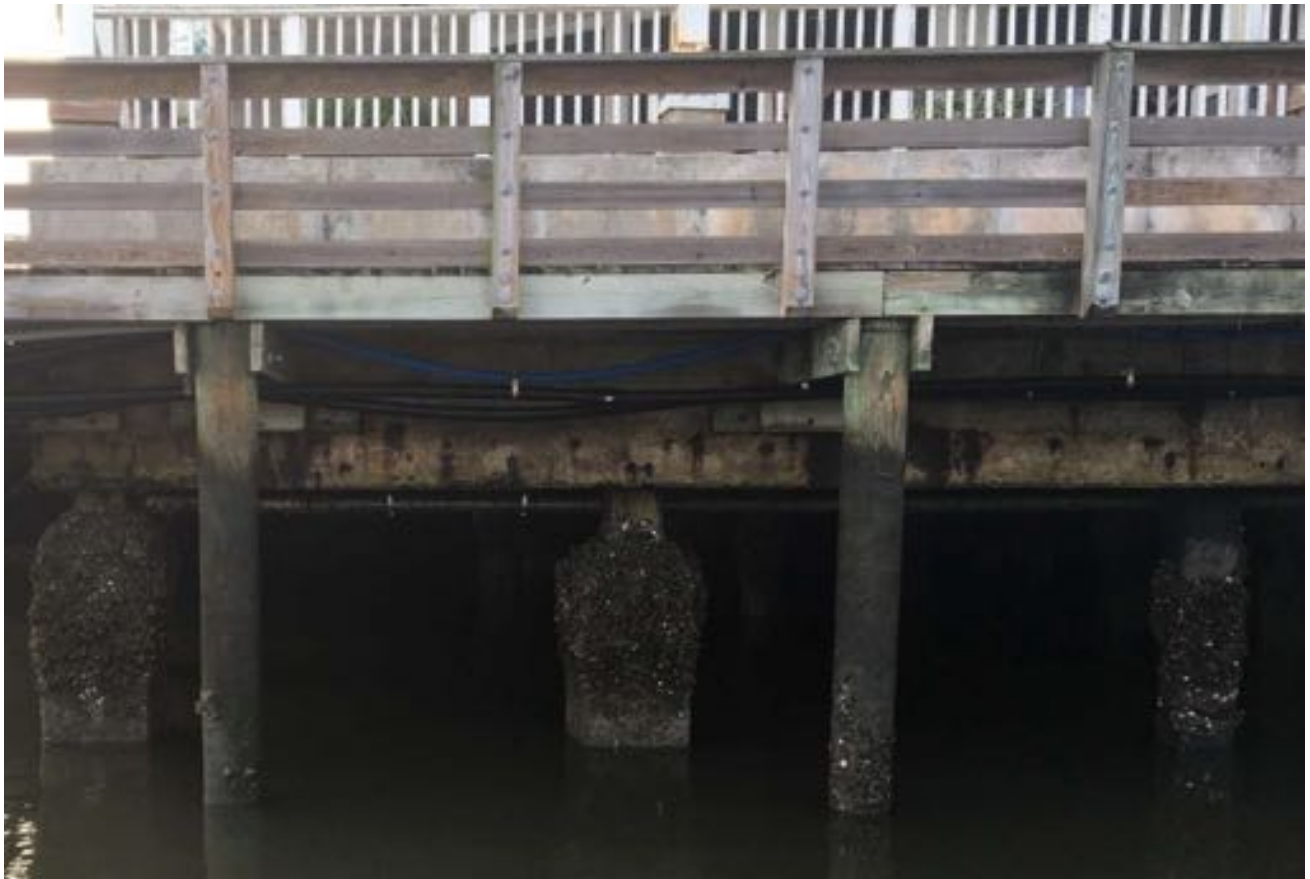
1.02~Enlarged view of West Elevation at the Northwest corner of the building. Horizontal cracking in the concrete beams and marine growth on piles.

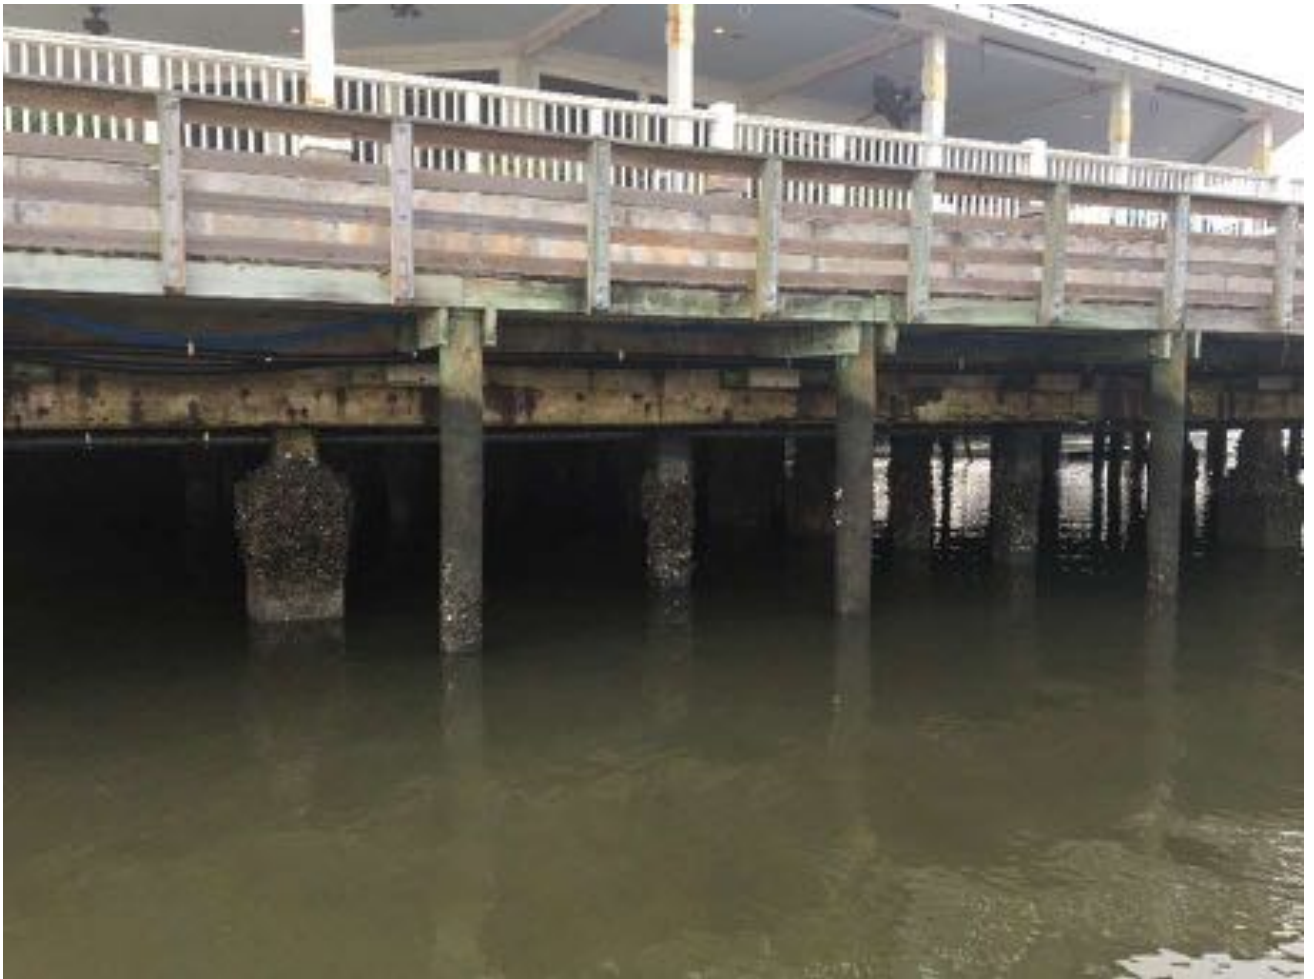
1.03~ West Elevation looking at the center of the building exterior. Concrete beams with multiple horizontal cracks. Marine growth on piles.

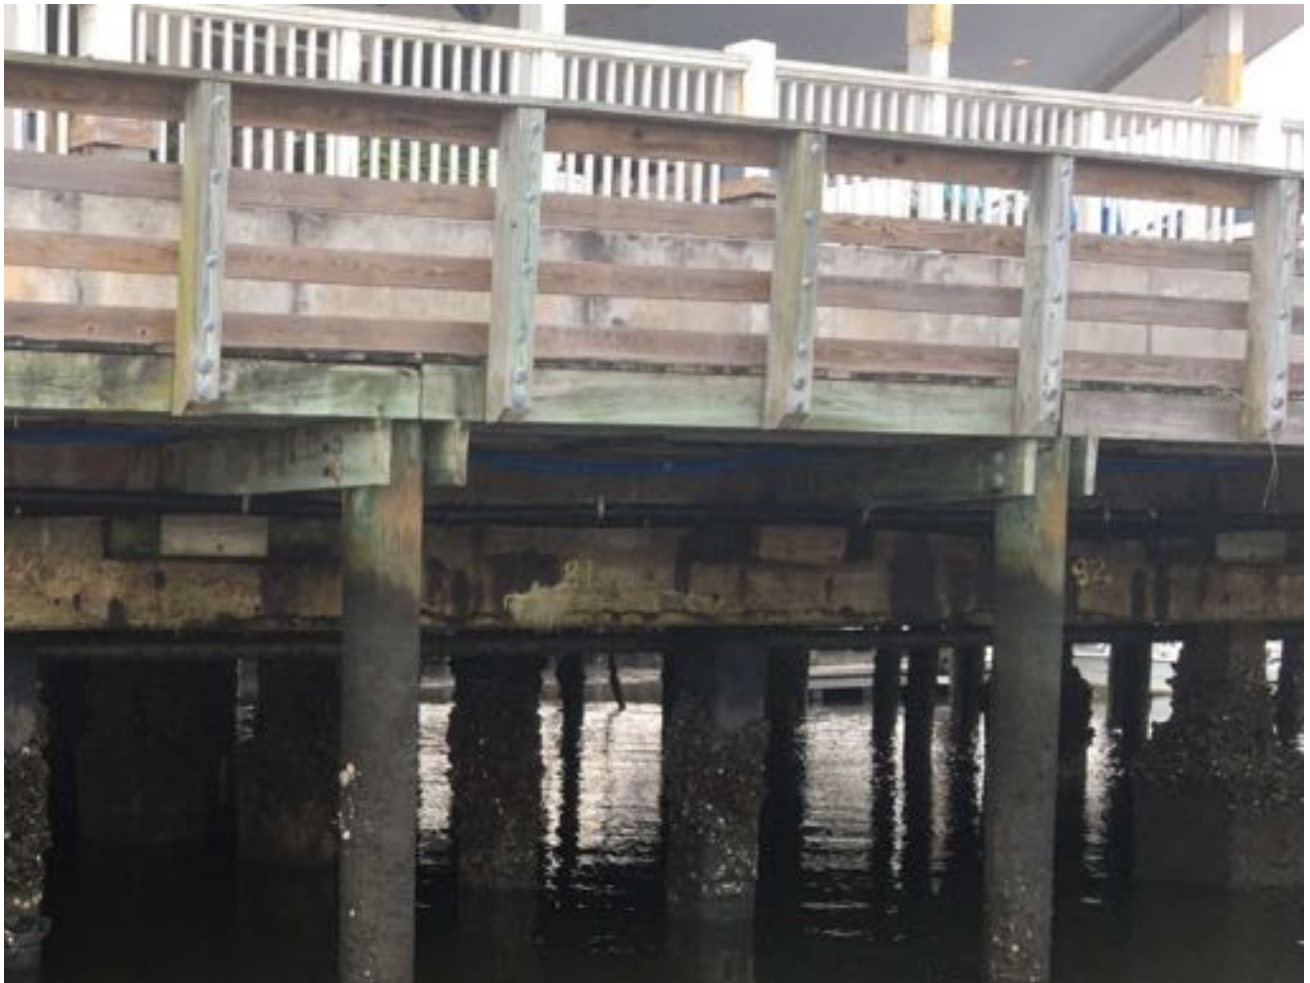
1.04~ Enlarged View of West Elevation looking at the center of the building exterior. Reinforced concrete beam / pile cap marked "B1" & "B2" by others in previous condition assessment with horizontal cracking at bottom of beam.

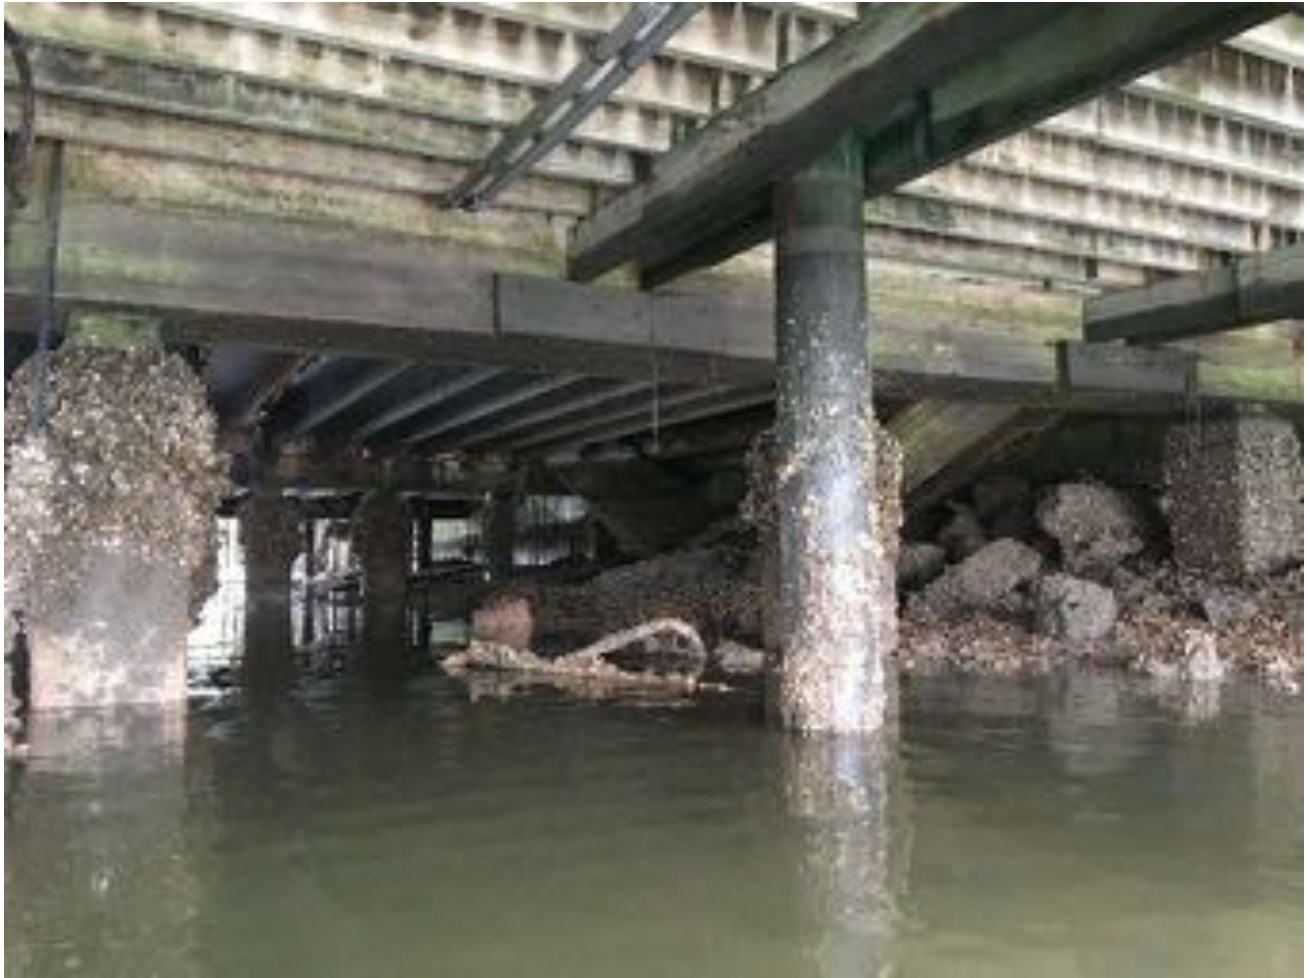
1.05~ Southeast portion of substructure. Timber piles and underside of boardwalk decking in the foreground. Reinforced concrete piles with marine growth in the background. Failed reinforced concrete lower double tee (1962) on righthand side of picture.

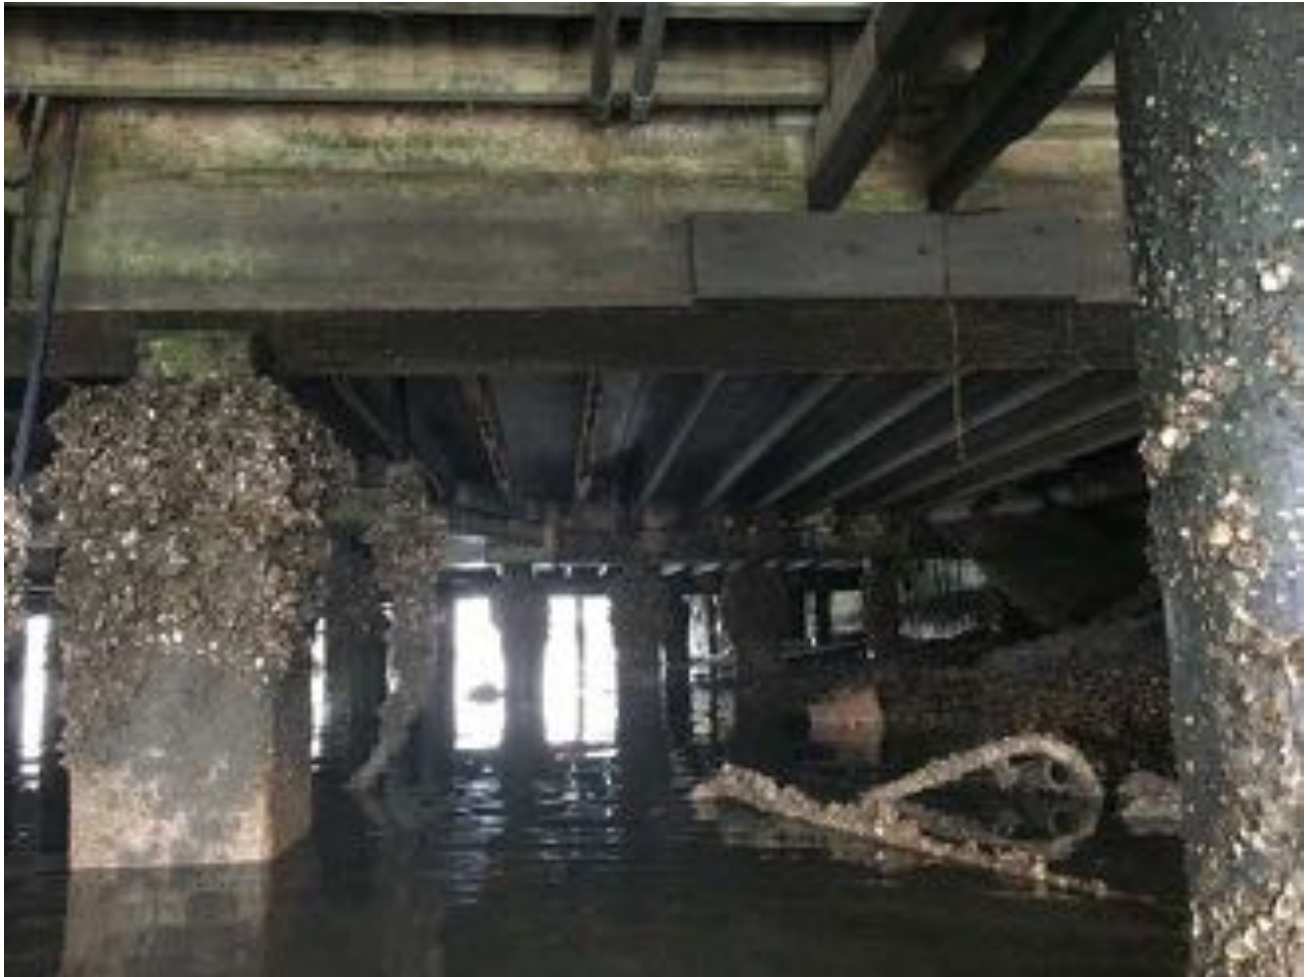
1.06~ Southeast portion of substructure. Timber piles and underside of boardwalk decking in the foreground. Reinforced concrete piles with marine growth in the background. Failed reinforced concrete lower double tee (1962) on righthand side of picture. Other lower double tees missing the bottom of their stems.

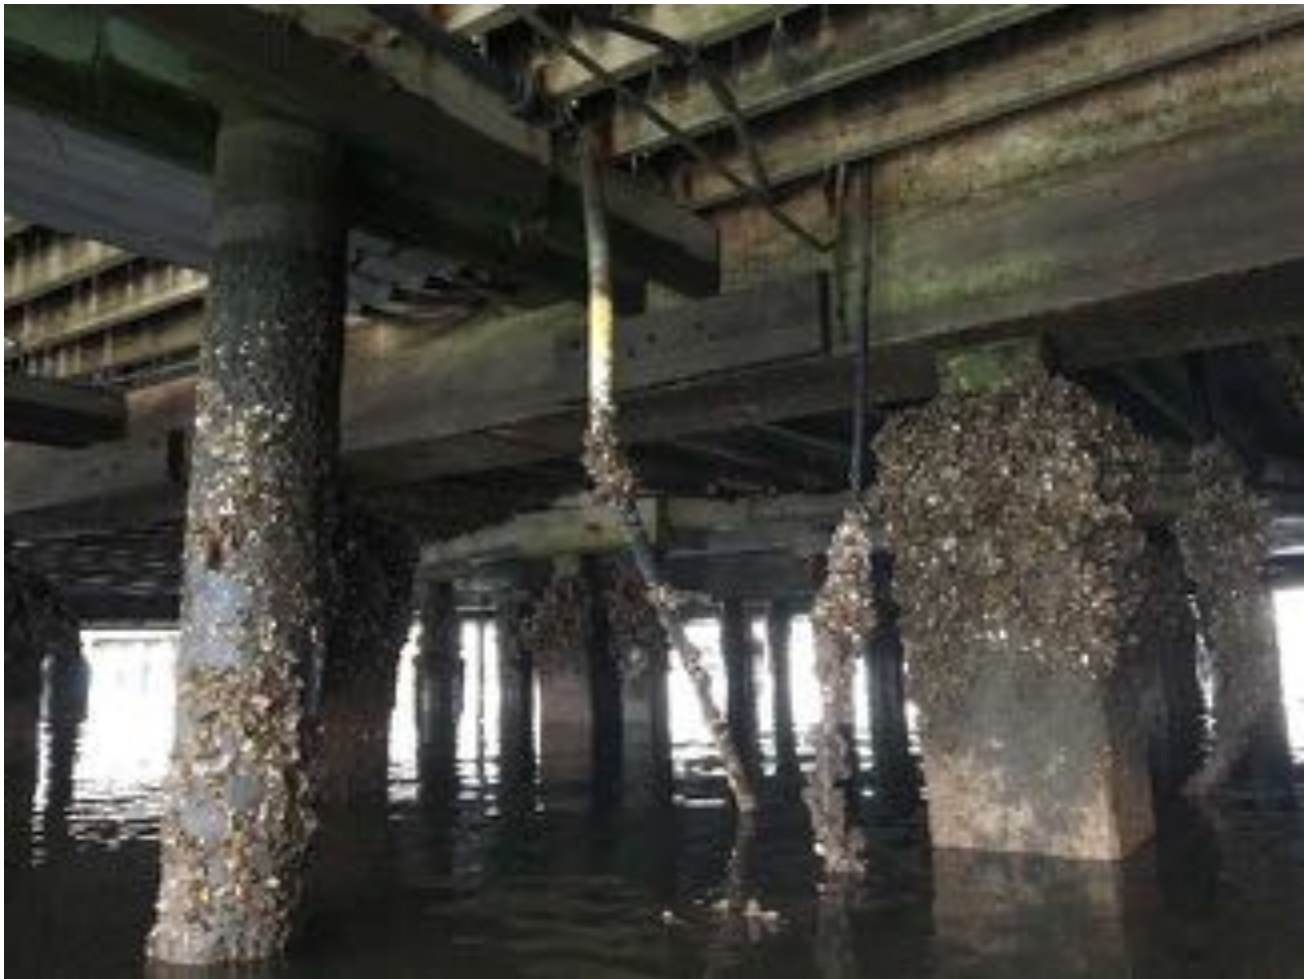
1.07~Southeast portion of substructure looking northwest. Concrete beams without visible defects. Piles with marine growth.

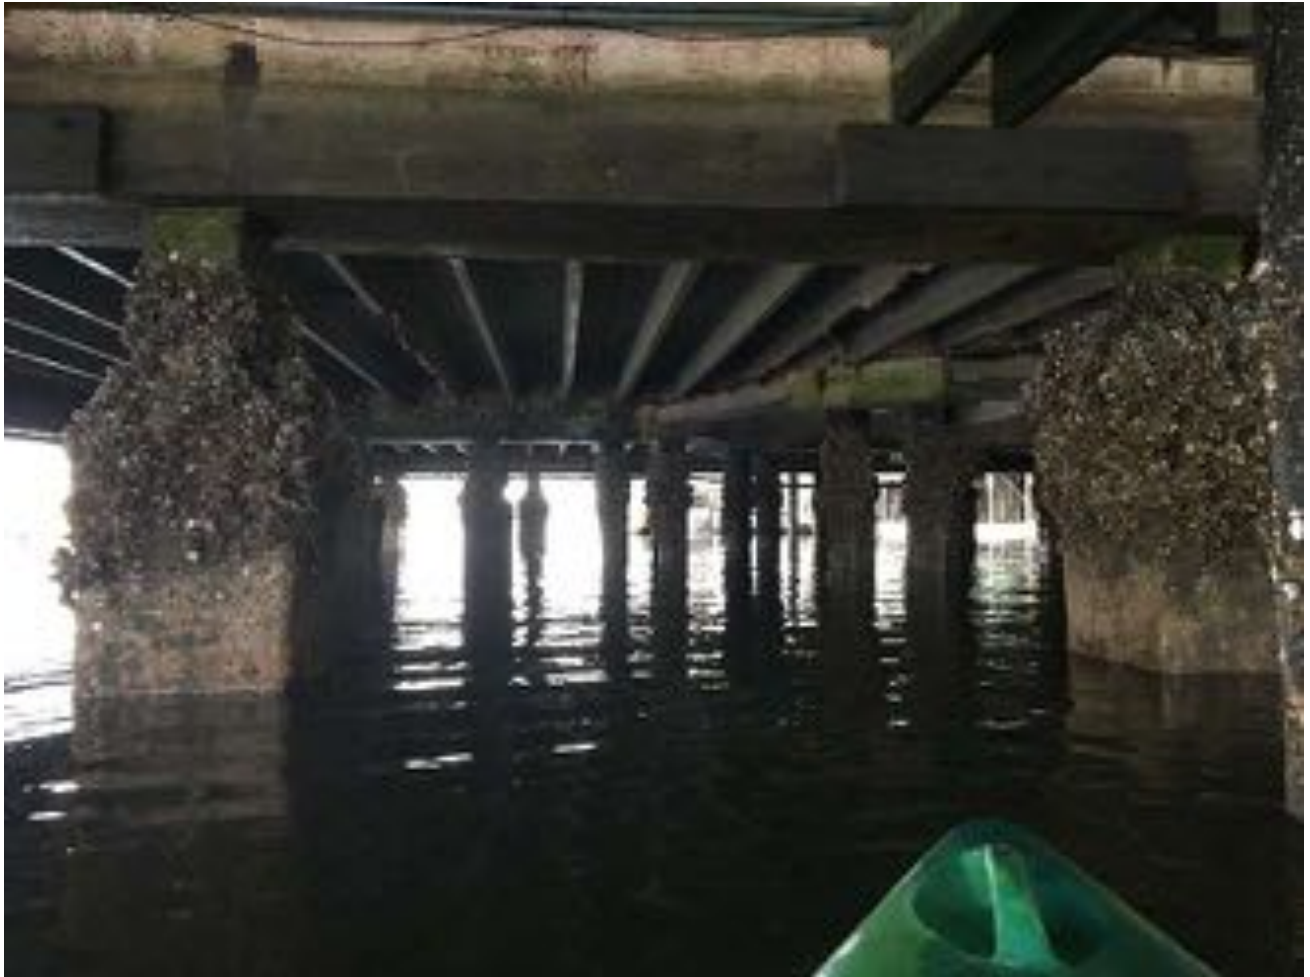
1.08~ South-central portion of substructure looking north. Lower double tees with missing portions of their stems. Concrete beams without visible defects. Piles with marine growth.

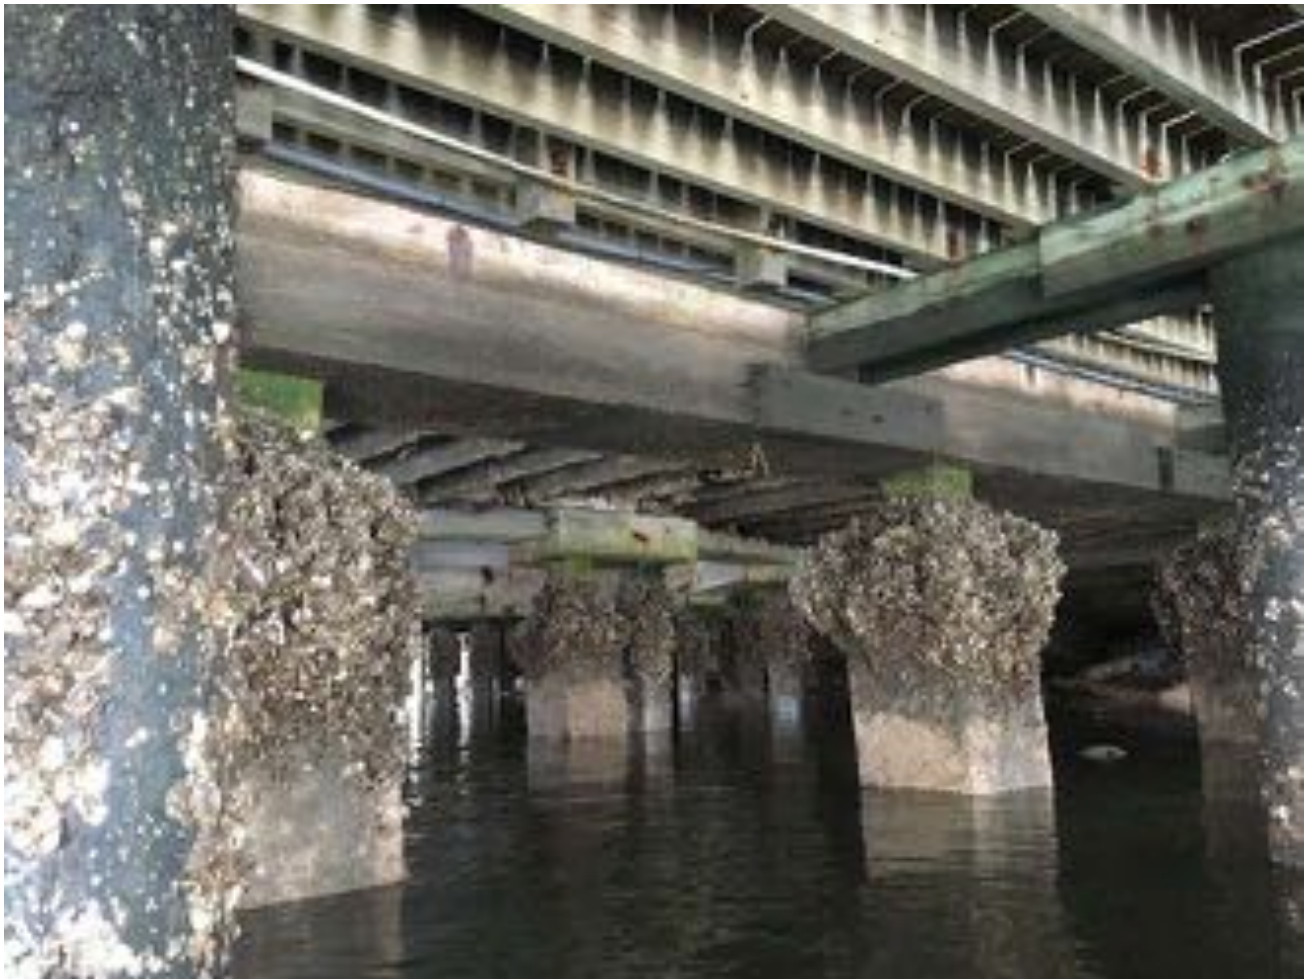
1.09~ South-central portion of substructure looking northeast. Lower double tees with missing portions of their stems. Concrete beams without visible defects. Piles with marine growth.

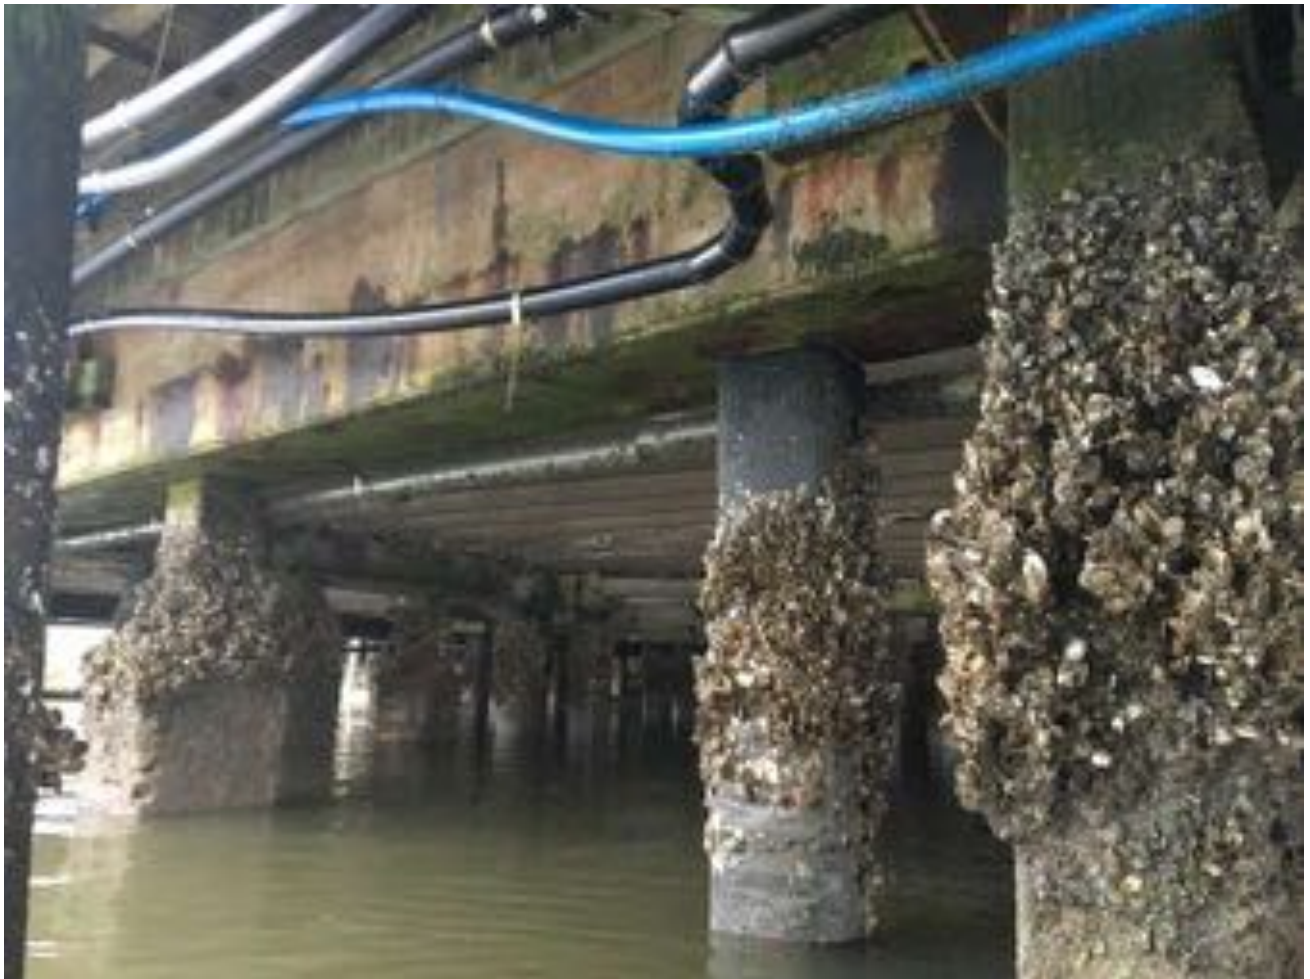
1.10~ Western portion of substructure looking northeast. Lower double tees with missing portions of their stems. Concrete beams with horizontal cracking and spalled concrete. Piles with marine growth.

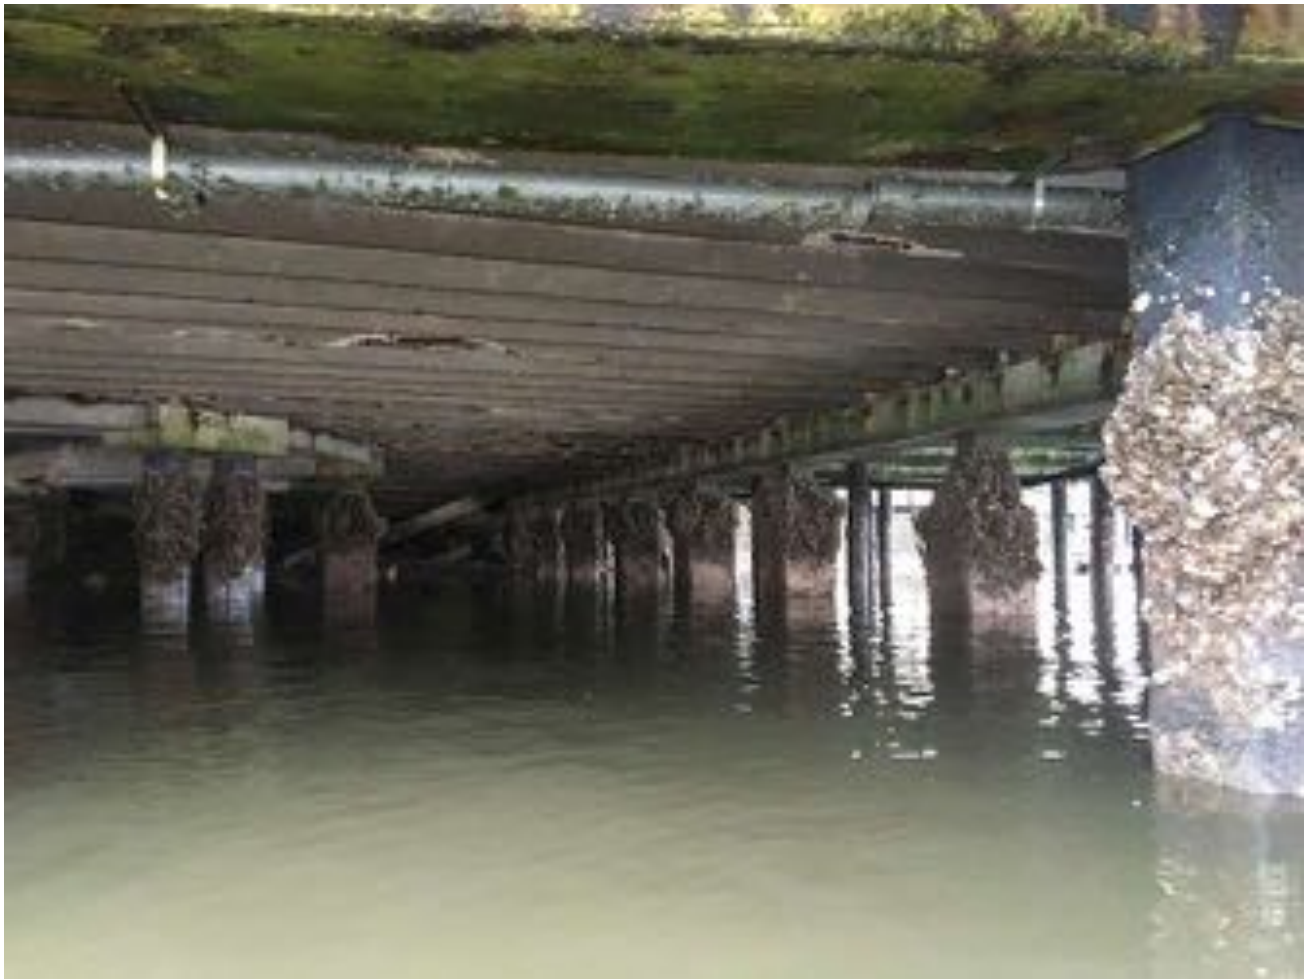
1.11~ Western portion of substructure near south side looking east. Lower double tees with missing portions of their stems. One of the lower double tees has failed and dropped into the river in the background of the picture. Concrete beams with horizontal cracking in the bottom face. Piles with marine growth.

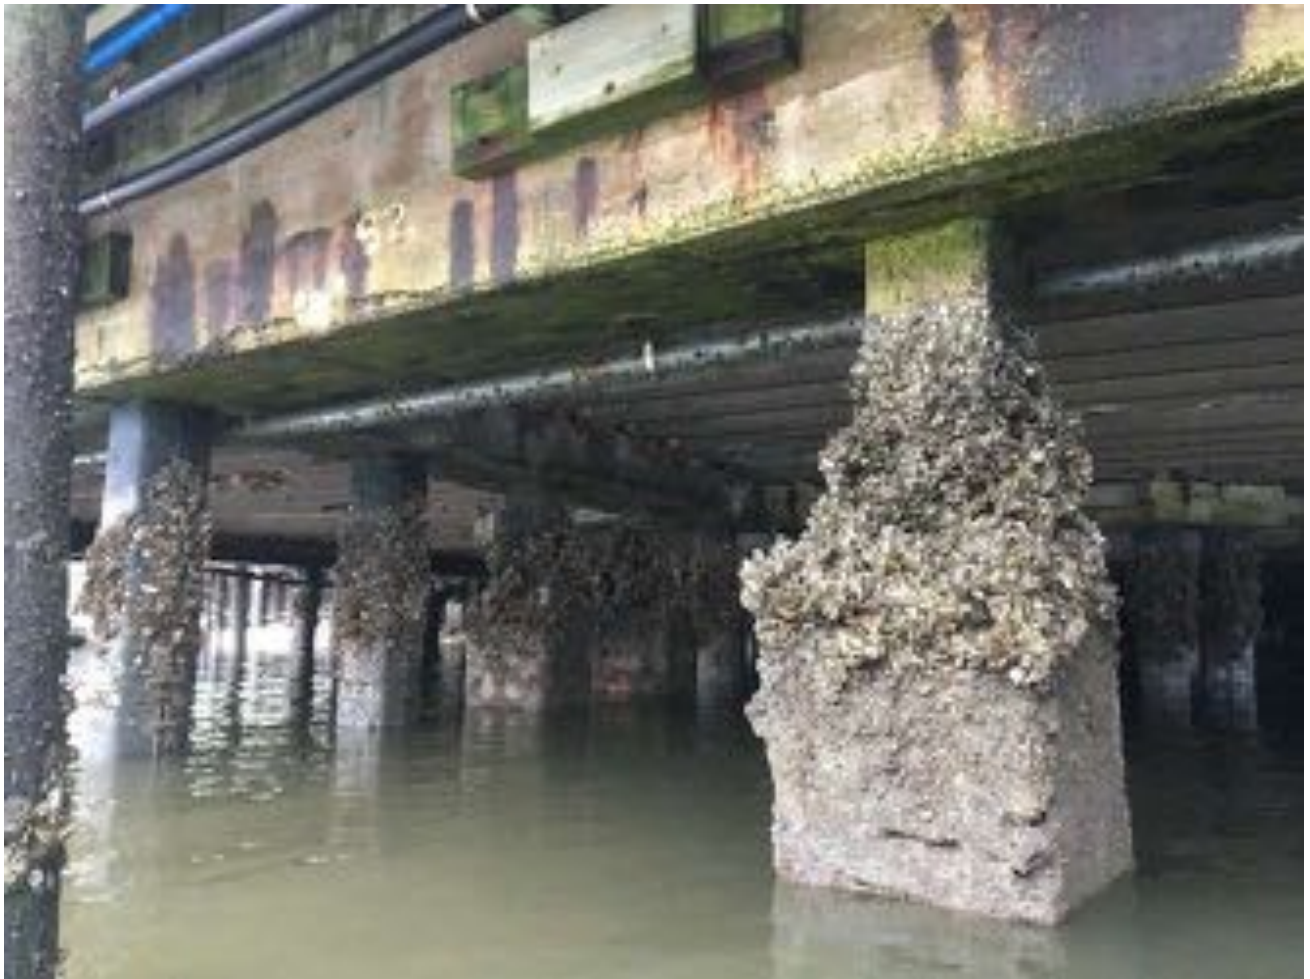
1.12~ West side of substructure looking northeast. Concrete beams with multiple horizontal cracks in bottom and side faces. Marine growth on piles.

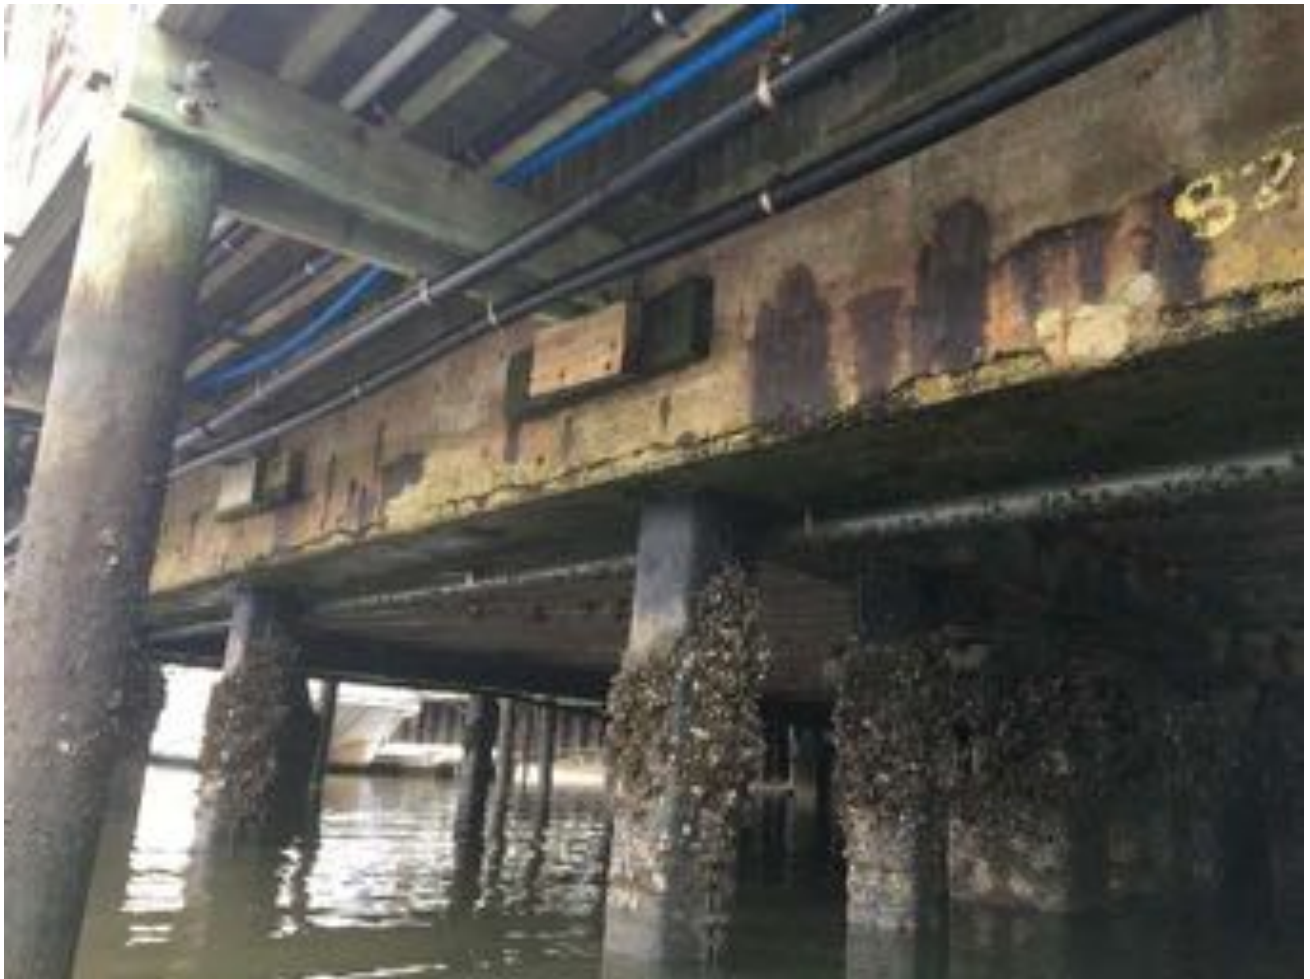
1.13~ West side of substructure looking northeast. Concrete beams with missing / spalled concrete and horizontal cracking; piles with some repairs and marine growth.

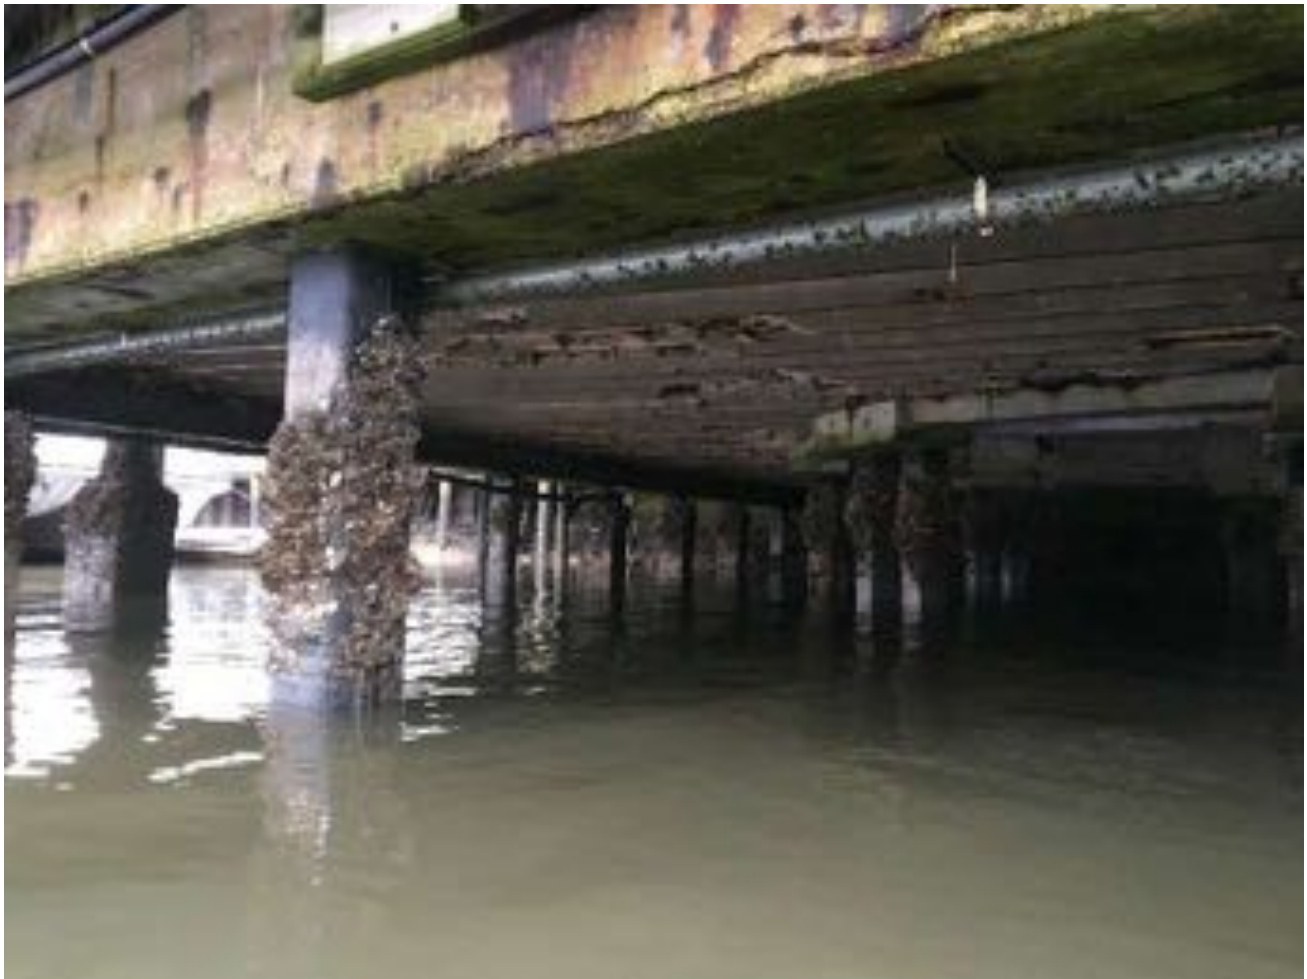
1.14~ West side of substructure looking northeast. Lower double tees with missing sections of the stem at the points of bearing and along the span; concrete beams with missing / spalled concrete and horizontal cracking; piles with some repairs and marine growth.

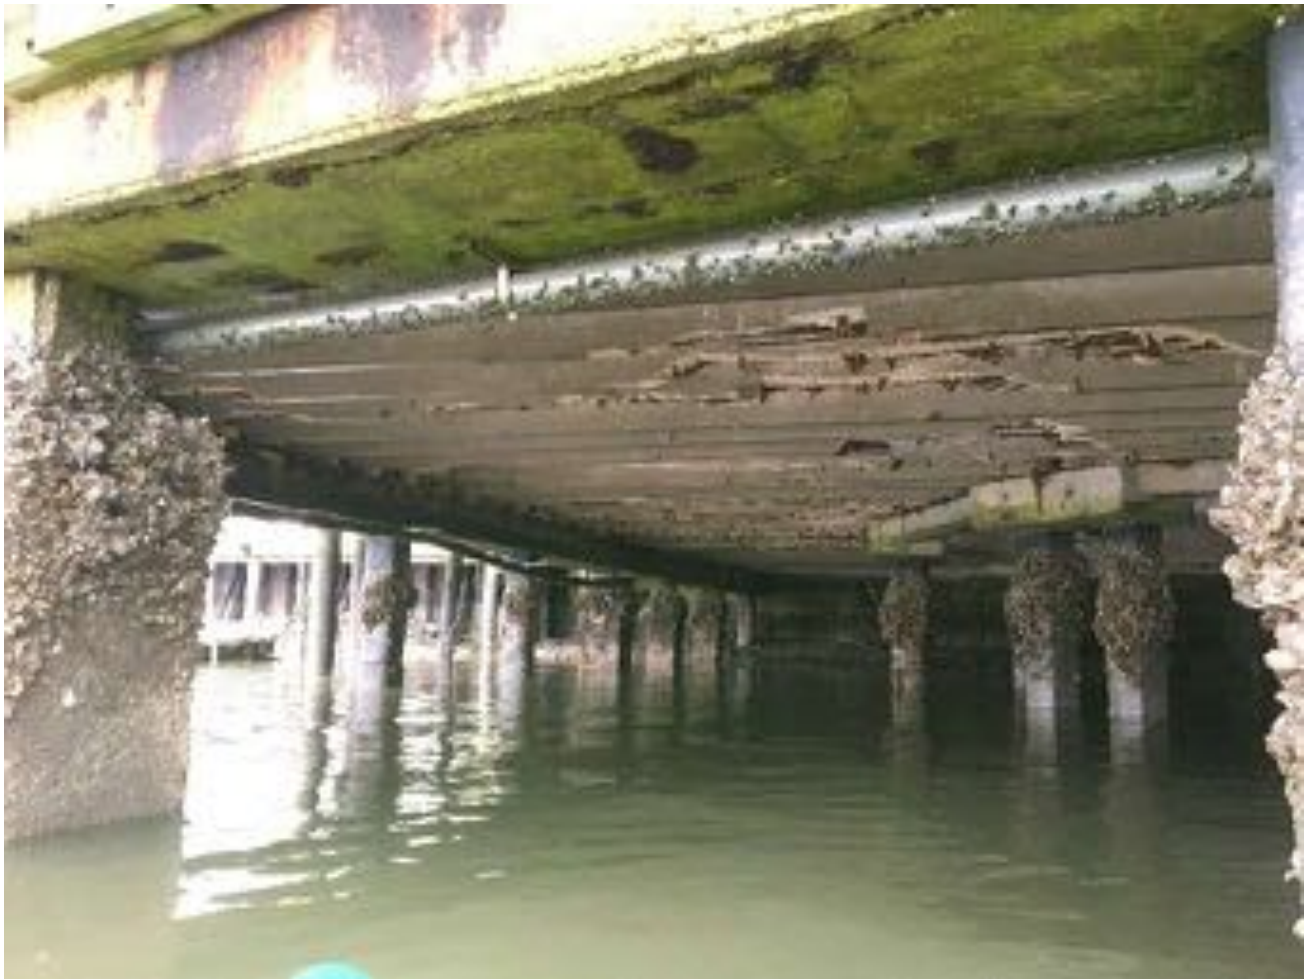
1.15~ West side of substructure near north side of structure looking east. Lower Double Tees with missing sections of the stem at the points of bearing and along the span; concrete beams with horizontal cracking in the bottom face; piles with some repairs and marine growth.

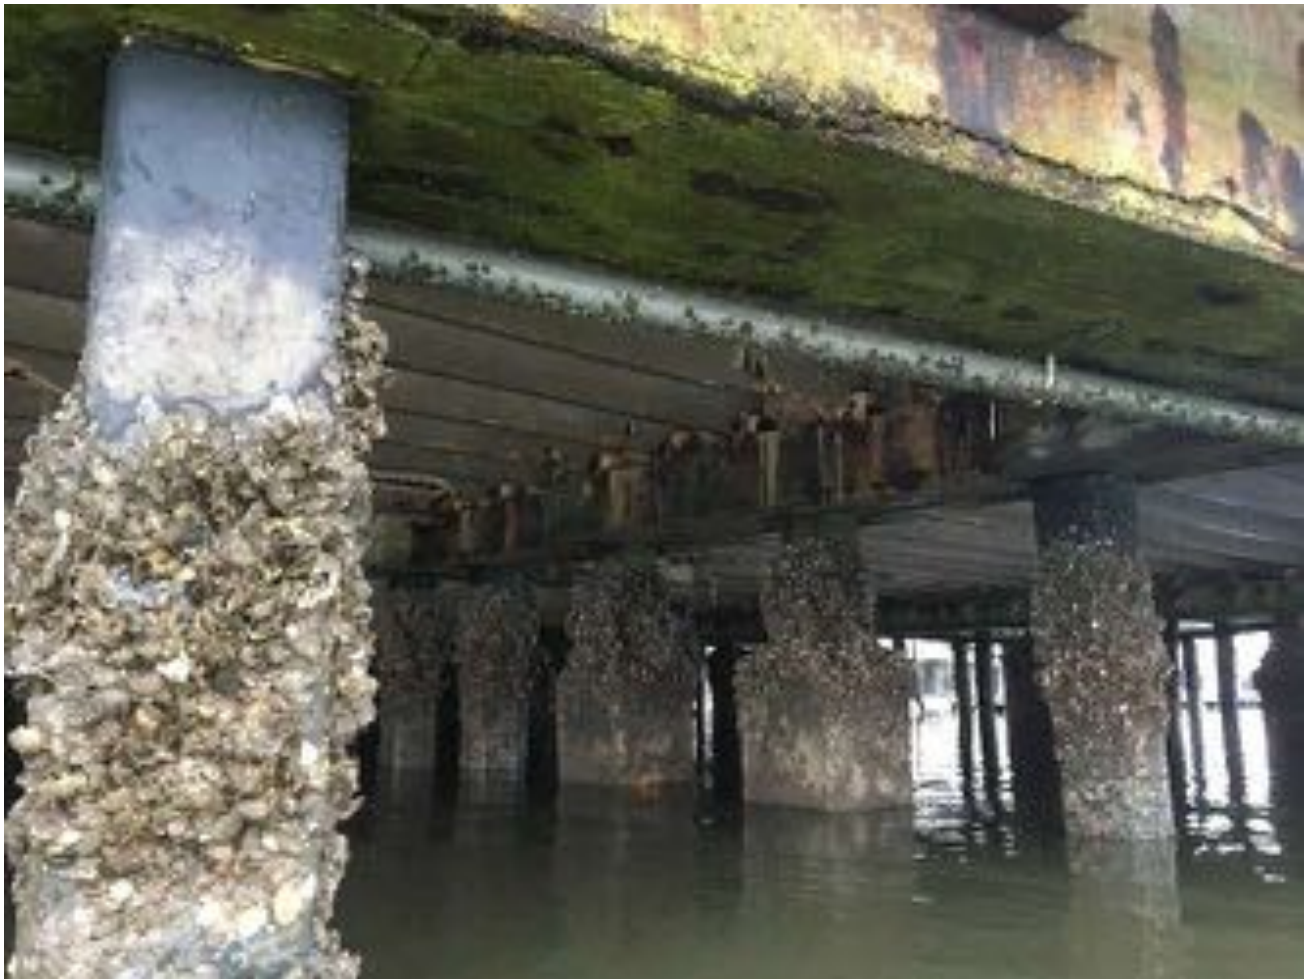
1.16~Lower double tees with missing sections of the stem at the points of bearing and along the span; concrete beams with horizontal cracking; piles with some repairs and marine growth.

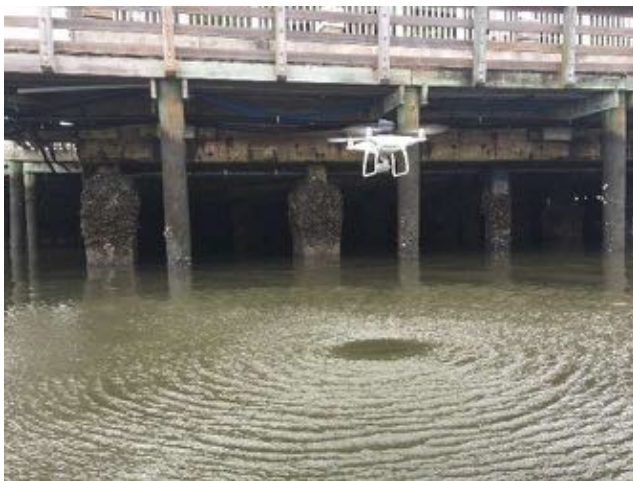
1.17~Aerial drone headed under building from the West

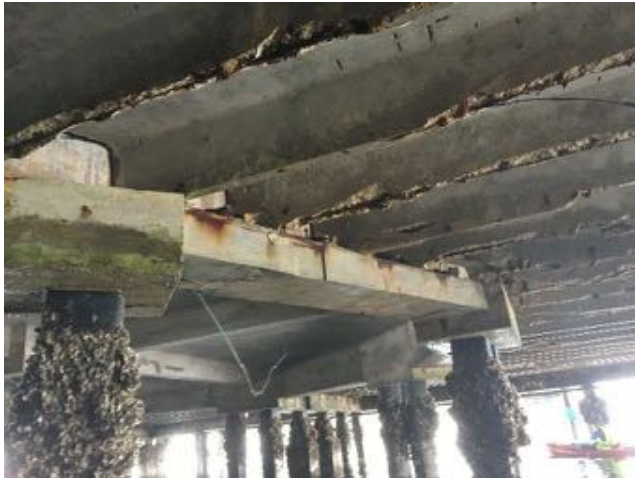
1.19~Lower double tees missing stems. Concrete beam in Octagon area with prior patching.

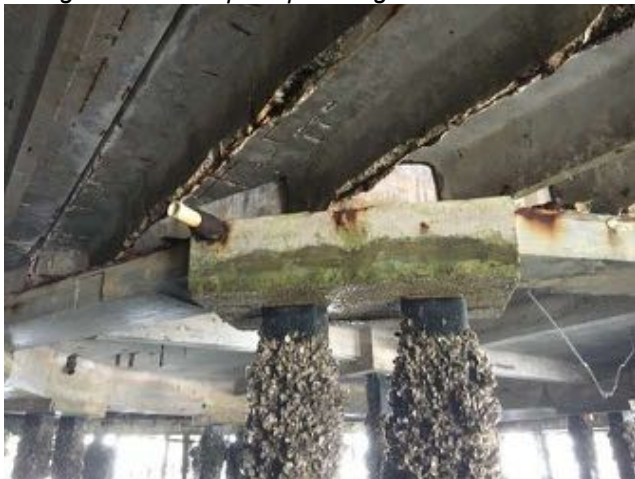
1.20~ Lower double tees missing stems. Concrete beam in Octagon area with patching and surface.
