BRETT'S WATERWAY CAFÉ SUBSTRUCTURE CONDITION ASSESSMENT

For the
CITY OF FERNANDINA BEACH, FLORIDA

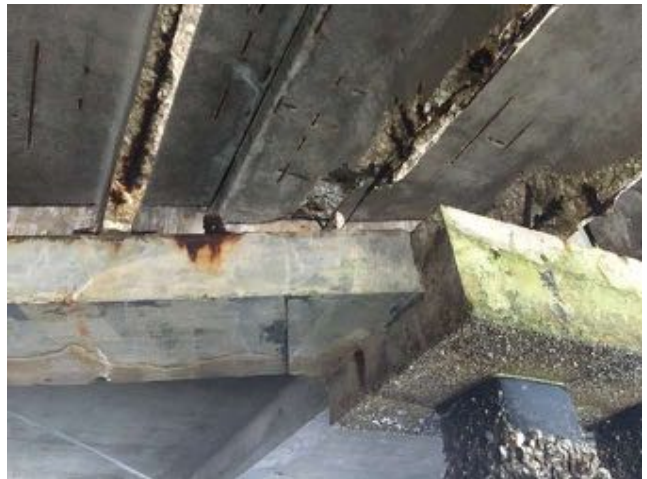
1.21~Lower double tees missing stems. Top of one Lower double tee has deflected. Concrete beams with patching.

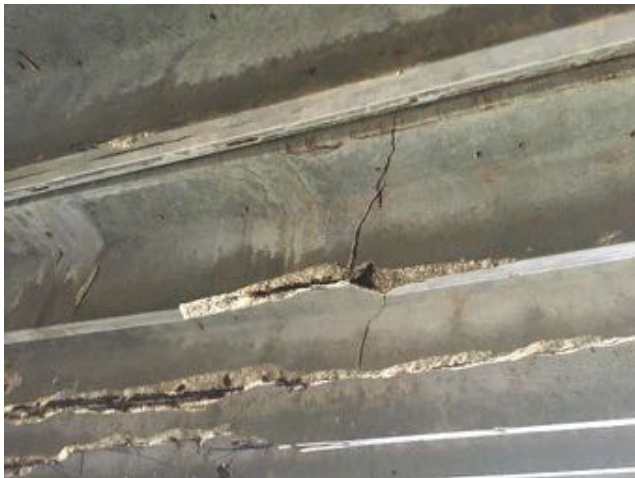
1.22~Lower double tee with full section crack, missing portions of stem, and deflection.

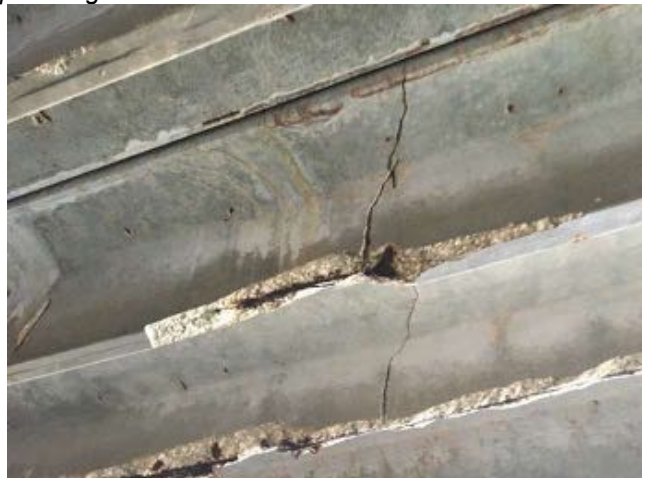
1.23~ Lower double tee with full section crack, missing portions of stem, and deflection.

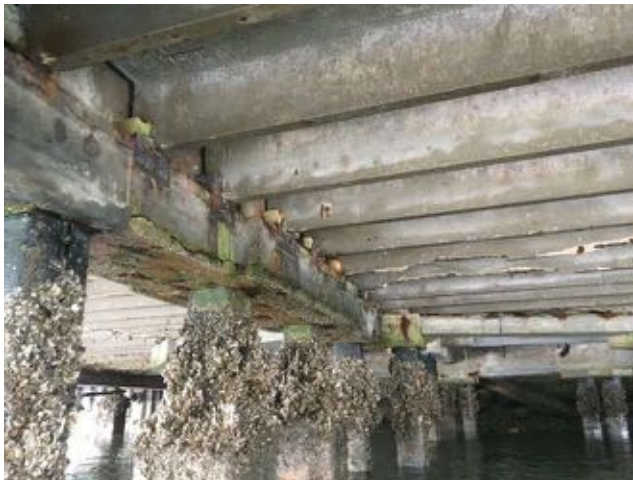
1.24~ Lower double tees with missing sections of the stem along the span; concrete beams with horizontal cracking; piles with marine growth.

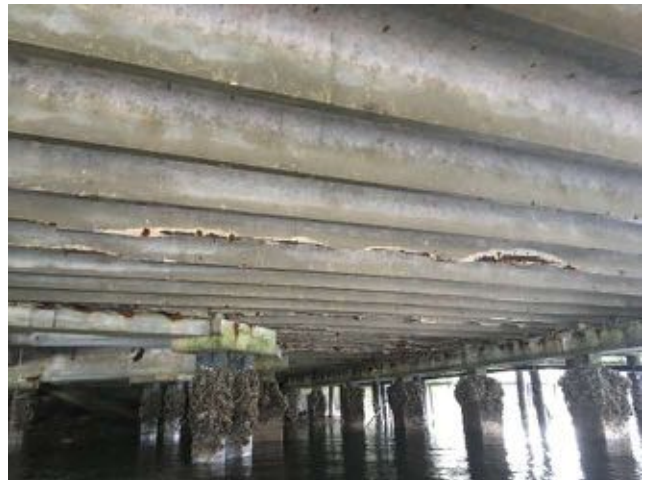
1.25~Lower double tees with missing sections of the stem along the span; concrete beams in fair condition; piles with marine growth.

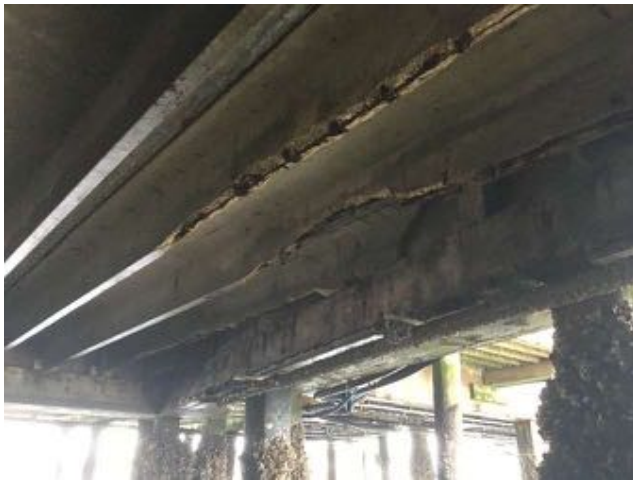
1.26~Southwestern corner of substructure; Lower double tees with missing sections of the stem along the span; concrete beam with horizontal cracking entire length of beam and missing bottom section at pile, righthand side of picture; piles with marine growth.

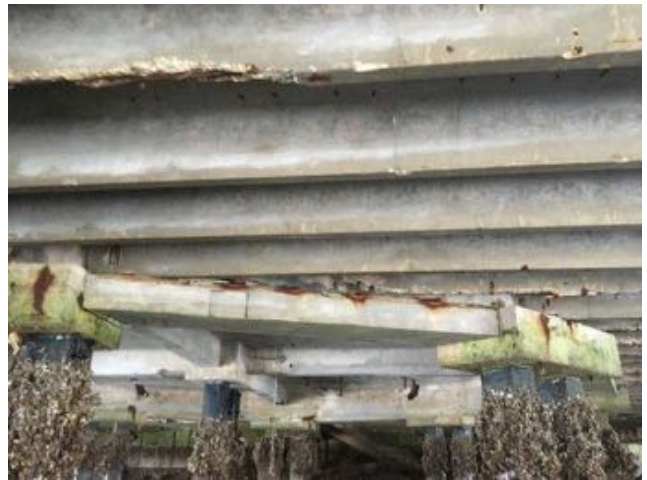
1.27~Lower double tees with missing sections of the stem along the span; concrete beams in good condition; piles with marine growth.

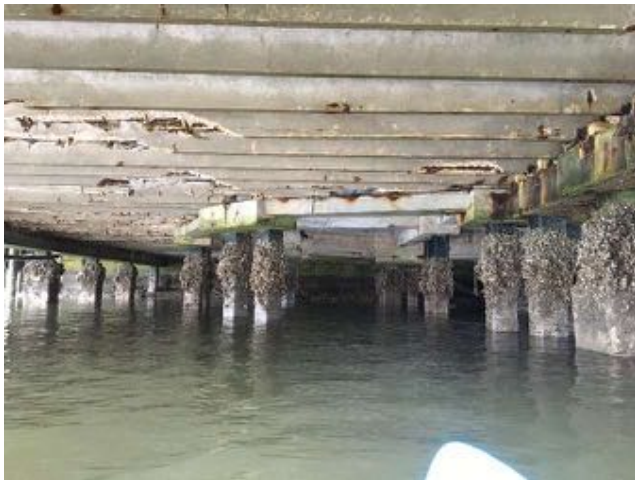
1.28~Northern portion of substructure; Lower double tees with missing sections of the stem at points of bearing and along the span; Octagonal area beams in good condition; beam on righthand side of picture has horizontal crack near bottom; piles with marine growth.

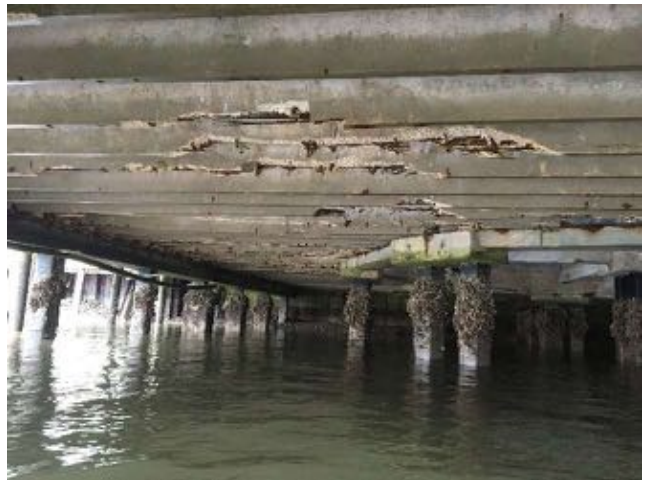
1.29~Northern portion of substructure; Lower double tees with missing sections of the stem along the span; Octagonal area beams in good condition; piles with marine growth.

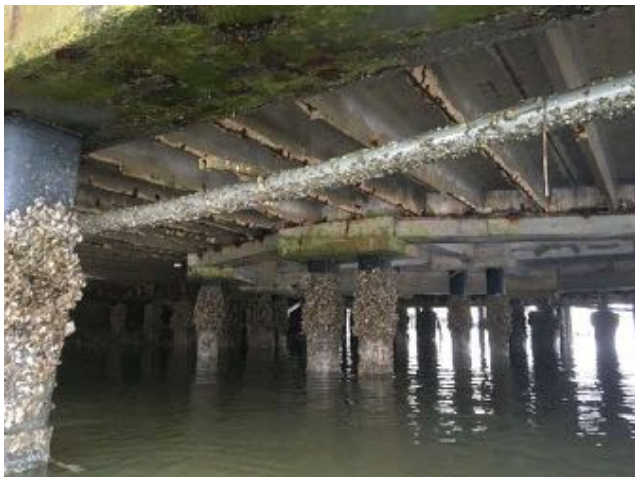
1.30~Northeast area of substructure looking southeast Lower double tees missing sections of the stem at points of bearing and along the spans; Octagonal area beams in fair condition with some patching; beam in picture foreground has cracking and spalling along bottom; piles with marine growth.

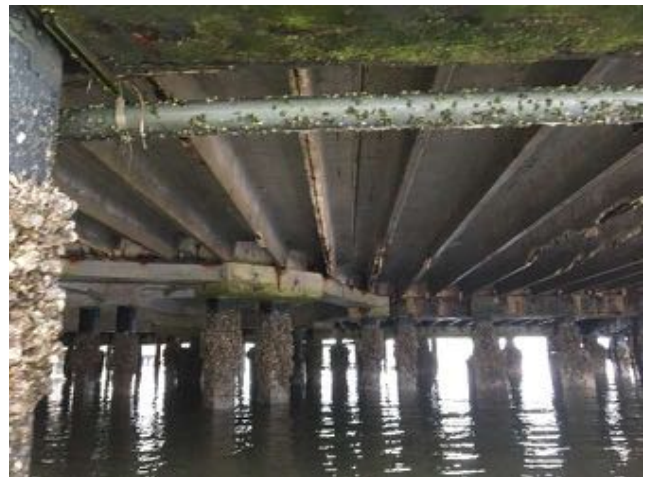
1.31~ Northeast area of substructure looking south; Lower double tees missing sections of the stem at points of bearing and along the spans; Octagonal area beams in fair condition with some patching; beam in picture foreground has cracking and spalling along bottom; piles with marine growth.

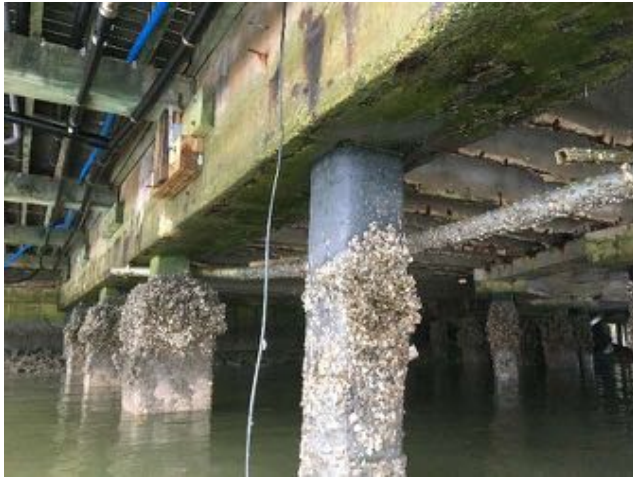
*1.32~Northeast area of substructure looking east
Lower double tees missing sections of the stem at
points of bearing and along the spans; Octagonal
area beams in fair condition with some patching; beam
in picture foreground has cracking and spalling along
bottom; piles with marine growth.*

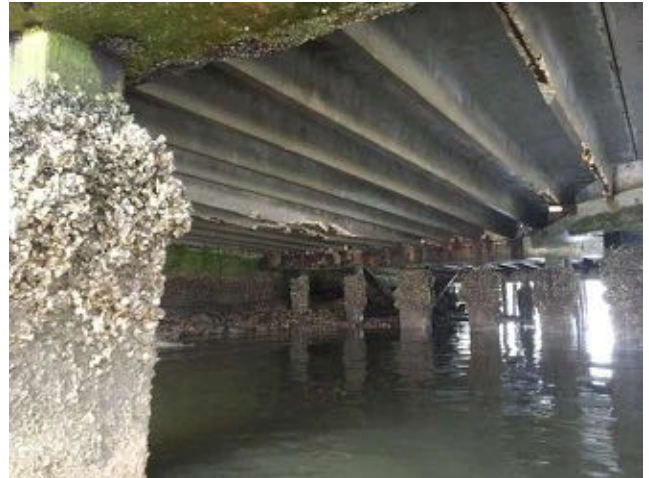
*1.33~ Northeast area of substructure looking south;
Lower double tees missing sections of the stem at
points of bearing and along the spans; Octagonal
area beams in fair condition with some patching;
beam in picture foreground has cracking and spalling
along bottom; piles with marine growth.*

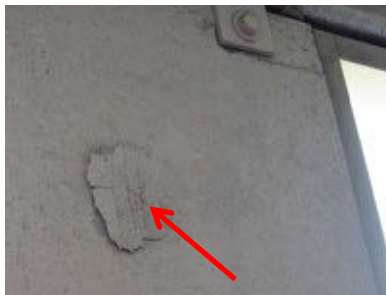
Figure 1: Failing Concrete Patch

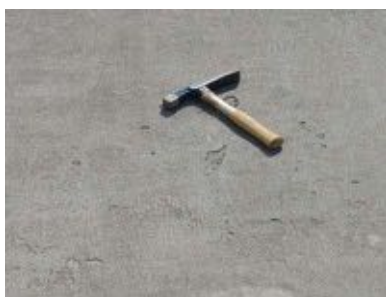
Figure 2: Concrete Delamination

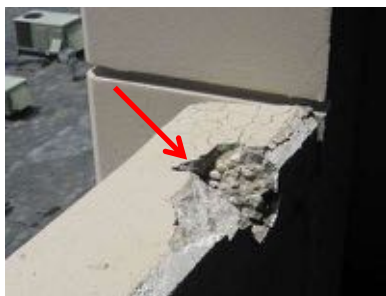
Figure 3: Concrete Spall

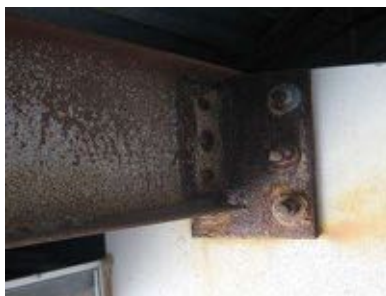
Figure 4: Structural Steel Corrosion and Scaling

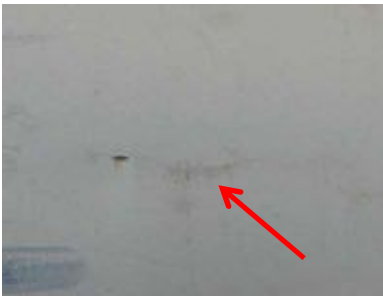
Figure 5: Fine Crack

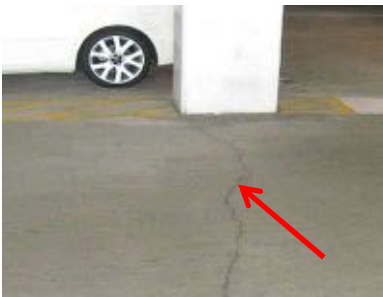
Figure 6: Medium Crack

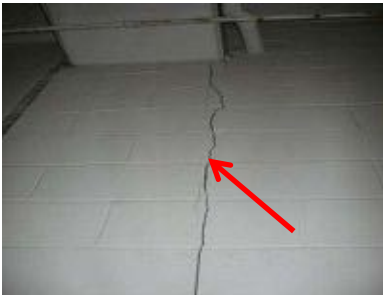
Figure 7: Wide Crack

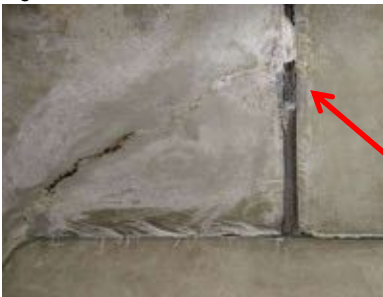
Figure 8: Leaking and Leaching Concrete

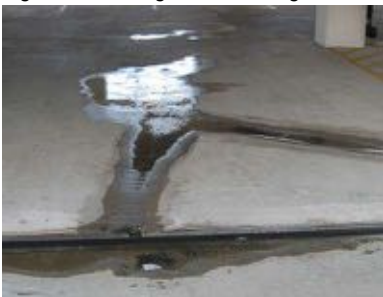
Figure 9: Ponding Water
